Neutral Citation Number: [2020] EWHC 2604 (Admlty)

IN THE HIGH COURT OF JUSTICE
QUEEN'S BENCH DIVISION
ADMIRALTY COURT

Collisions in the Suez Canal, 15 July 2018

Approved Judgment

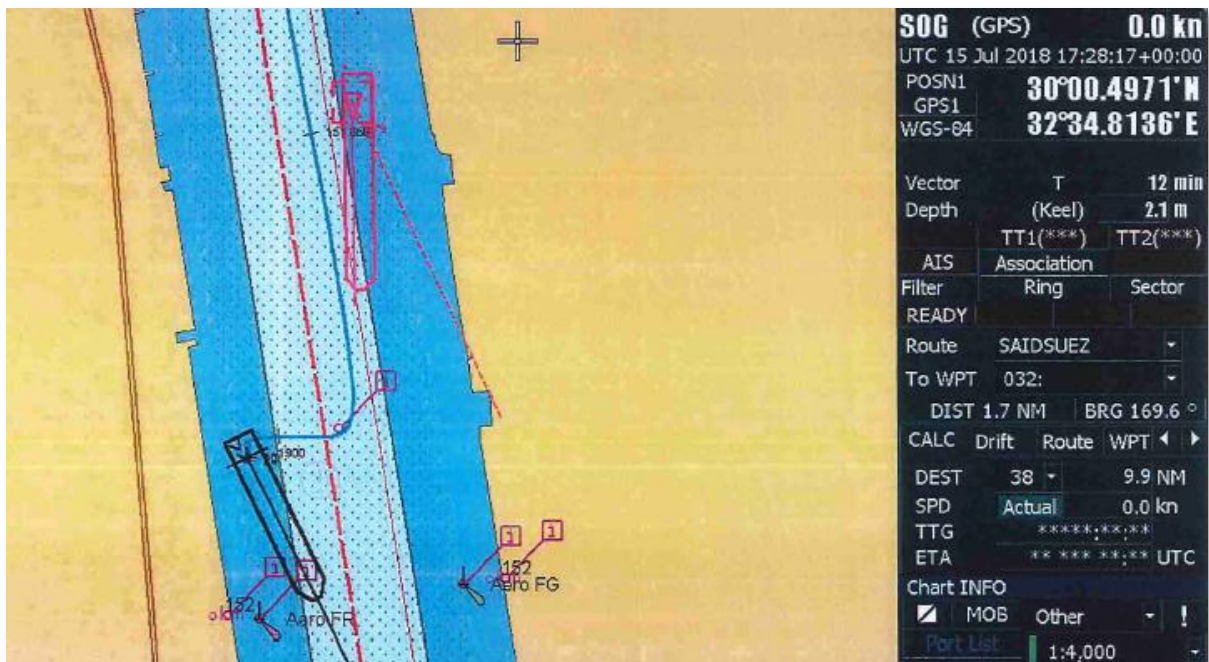
131. A screenshot from OD’s ECDIS at 1928 illustrates the positions of SK and OD in the Canal as PA approached them.

Figure 1 – 19:28LT – OD ECDIS Screenshot of SK and OD before 1st Collision

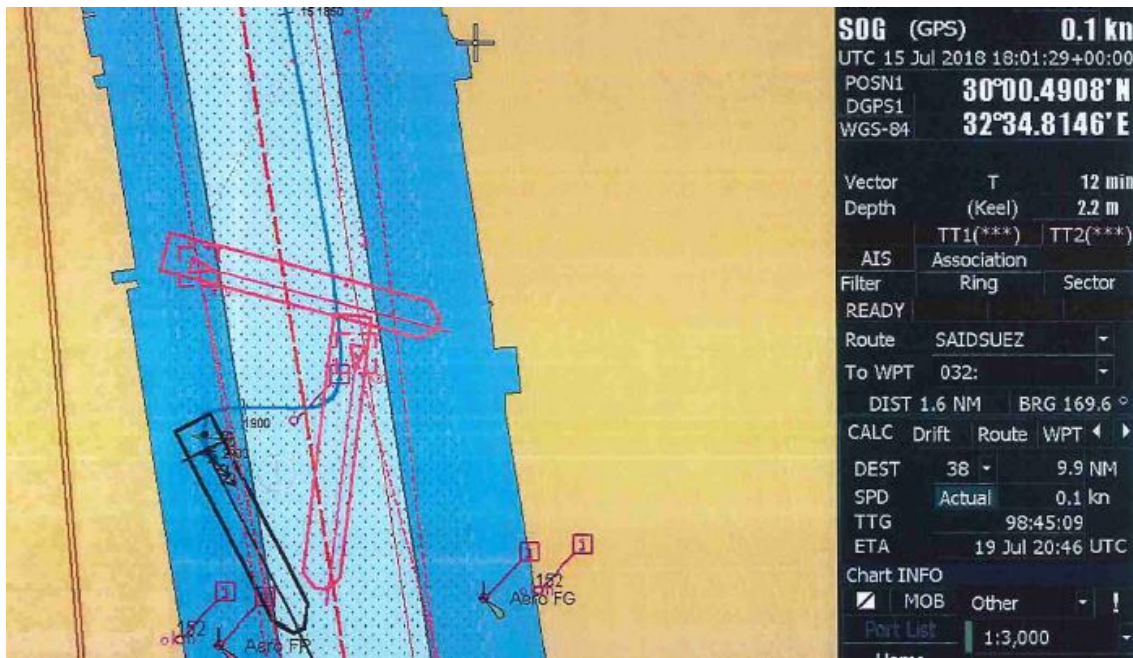
Figure 3 - 20:01LT

165. Two screenshots from OD’s ECDIS at 2001 and 2002 illustrate the manner in which SK’s stern swung to starboard and PA’s bow moved towards OD.

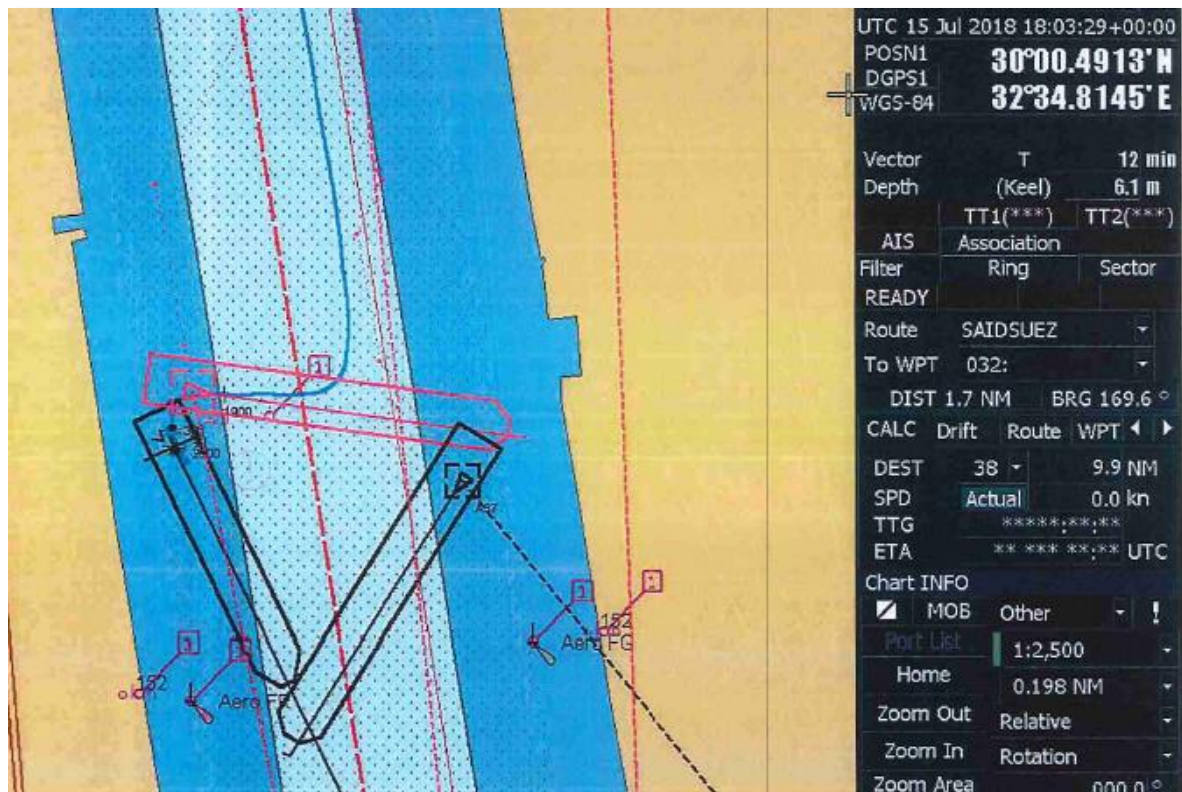
166. By about 2003, when SK was heading about 100°, her starboard quarter struck the port quarter of OD. At about the same time, and as recorded in OD's log, PA struck OD on her port side forward. It has been said on behalf of OD that there was contact between OD's railing and PA's starboard hawse pipe which was described on behalf of PA as minor. However, this is not the occasion to determine the extent of damage caused by this collision.
167. A screenshot from OD's ECDIS illustrates the collisions at 2003 and the remarkable triangle formed by the vessels.

Figure 5 - 20:03LT – The later collisions

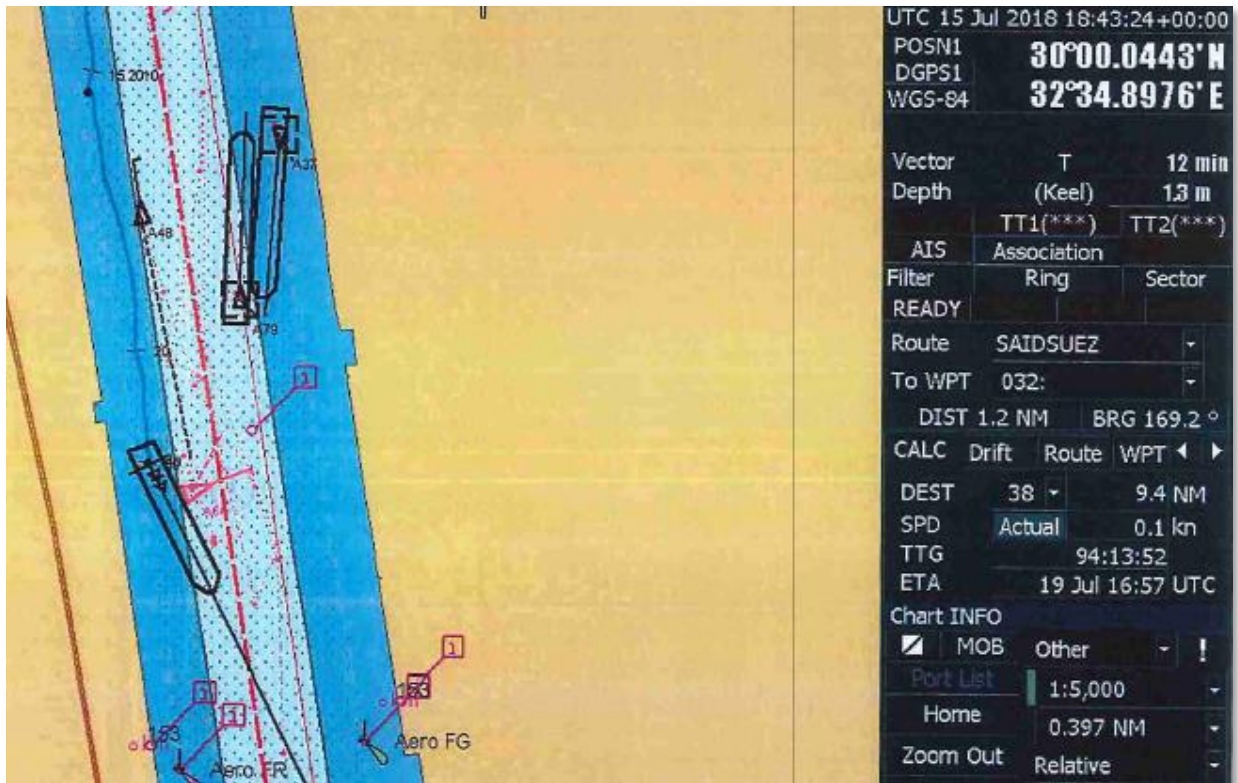
Figure 6 - from 20:25LT - All vessels stopped
