IN THE HIGH COURT OF JUSTICE
QUEEN'S BENCH DIVISION
TECHNOLOGY AND CONSTRUCTION COURT

**Leeds Beckett University (formerly Leeds
Metropolitan University)**

Travelers Insurance Company Limited

Judgment Approved

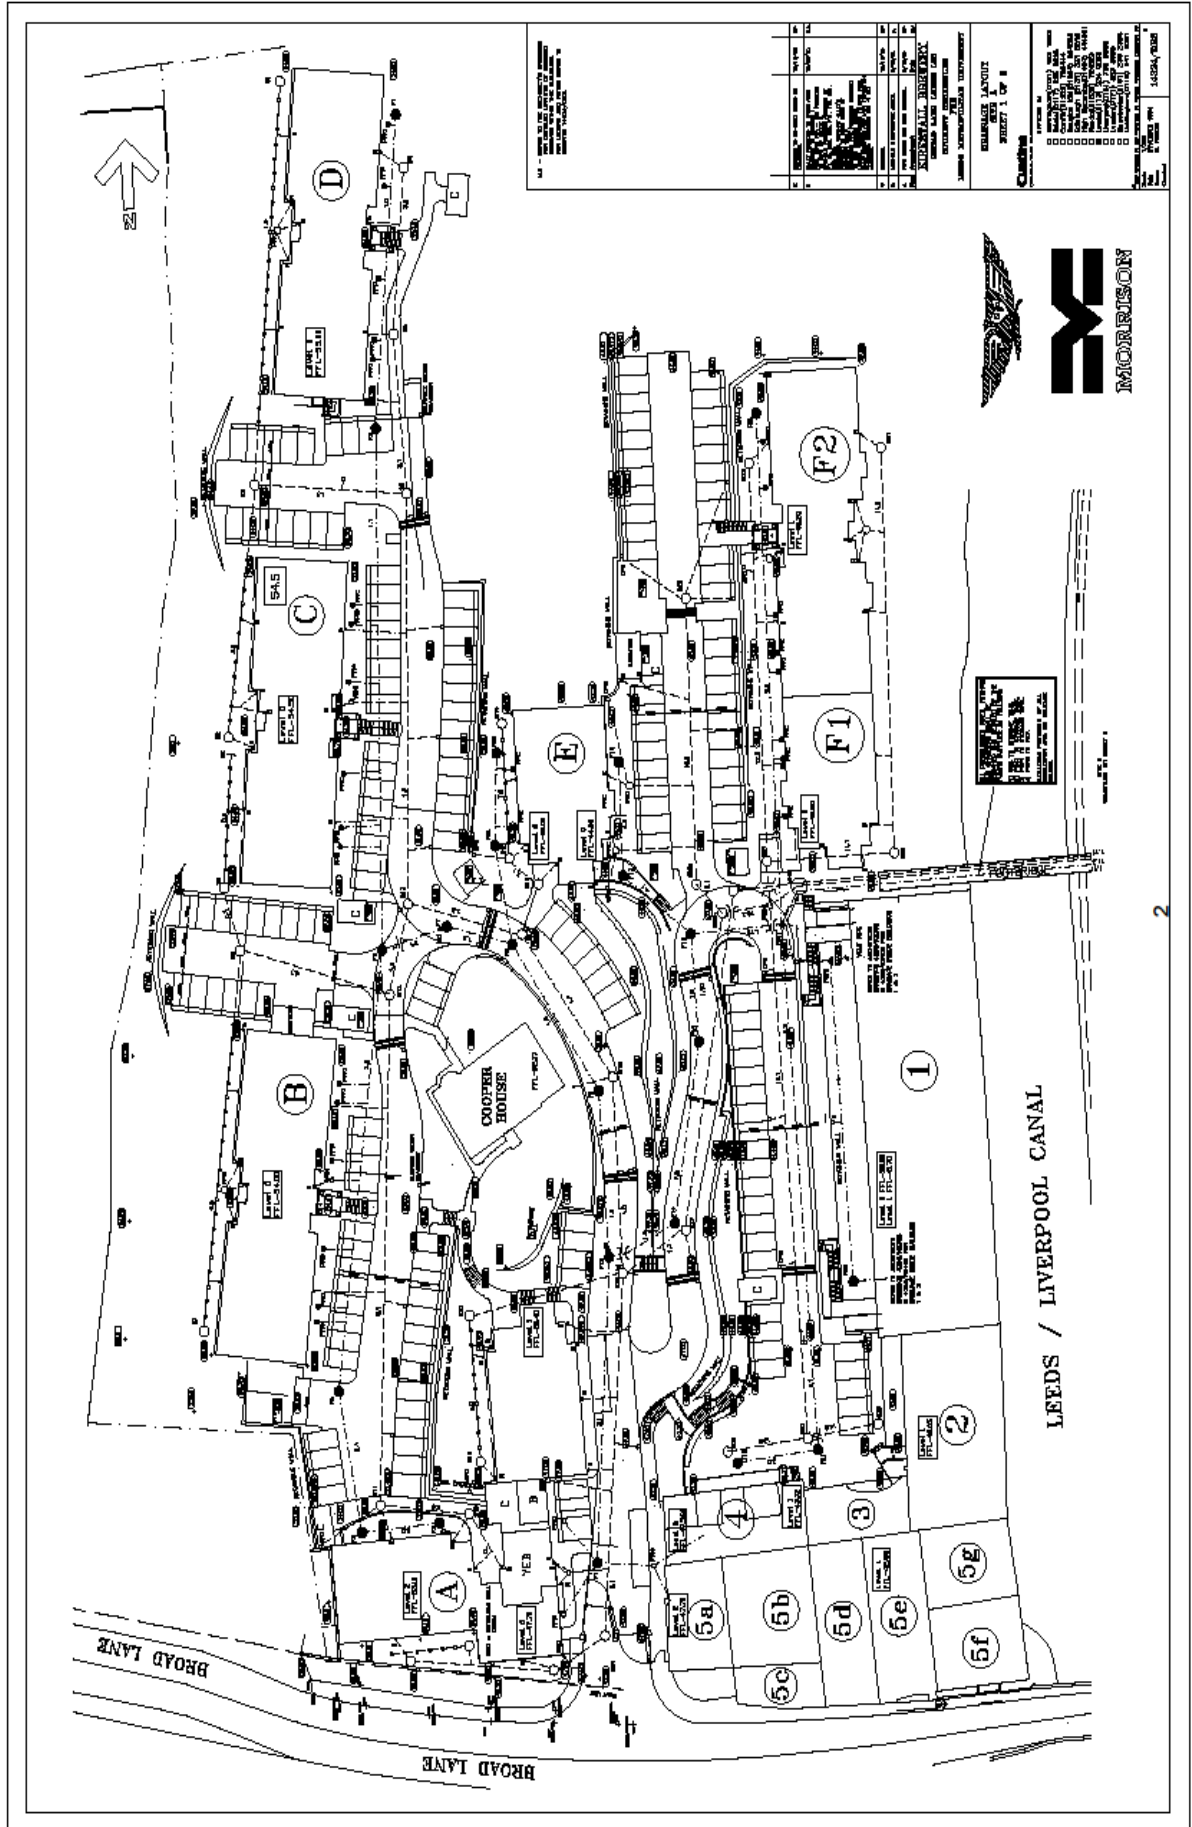
1. Between 1993 and 1996, the claimant (“the University”) carried out an ambitious building project on the site of the former Kirkstall Brewery, on both sides of the Leeds-Liverpool canal in north-west Leeds. The project involved not only the refurbishment of the existing brewery buildings, but the design and construction of several new accommodation blocks. Because these blocks were designed to match the existing buildings, they were, from an aesthetic point of view, considerably more attractive than the typical undergraduate block. The largest of these buildings, containing both the Bridge Building (F1) and the Turner Building (F2), was located adjacent to the western bank of the canal. I shall call it “the F1/F2 Building”. It is shown on *Figure 1*.

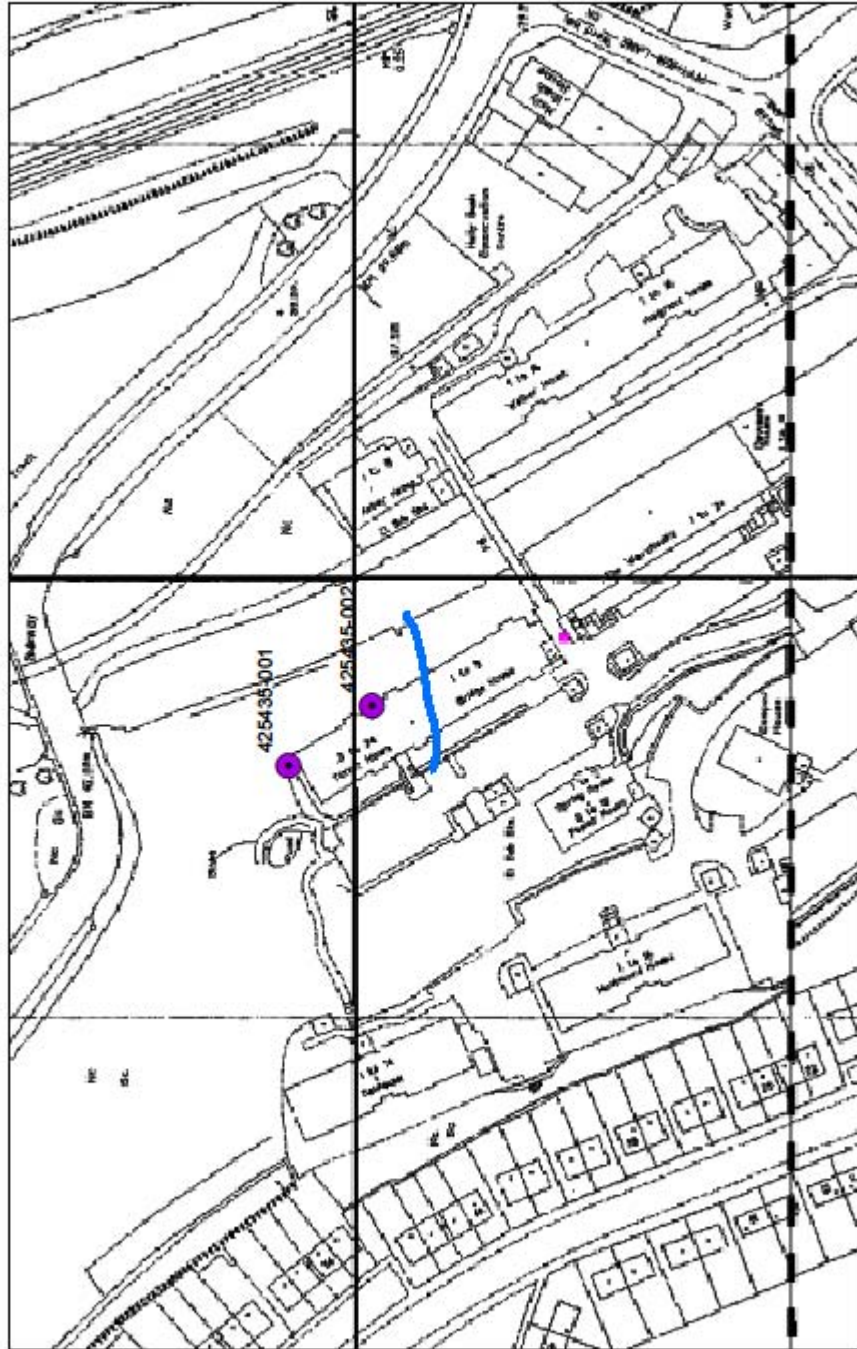
31. The map provided by British Coal with their letter was dated 19 November 1993. It showed the locations of the two mine shafts to which they had referred. They were on the north-eastern side of the site, just to north of the watercourse. The map described them as “the approximate location(s) of known disused coal mine outlets under or close to the property to which the attached report relates...”
32. Investigations have shown that the location of the southern mineshaft (as indicated by British Coal) was within the footprint of the F1/F2 Building, in the area of the greatest blockwork damage. The northern location was just beyond the north-eastern corner of the F1/F2 Building. They are marked on *Figure 2*.

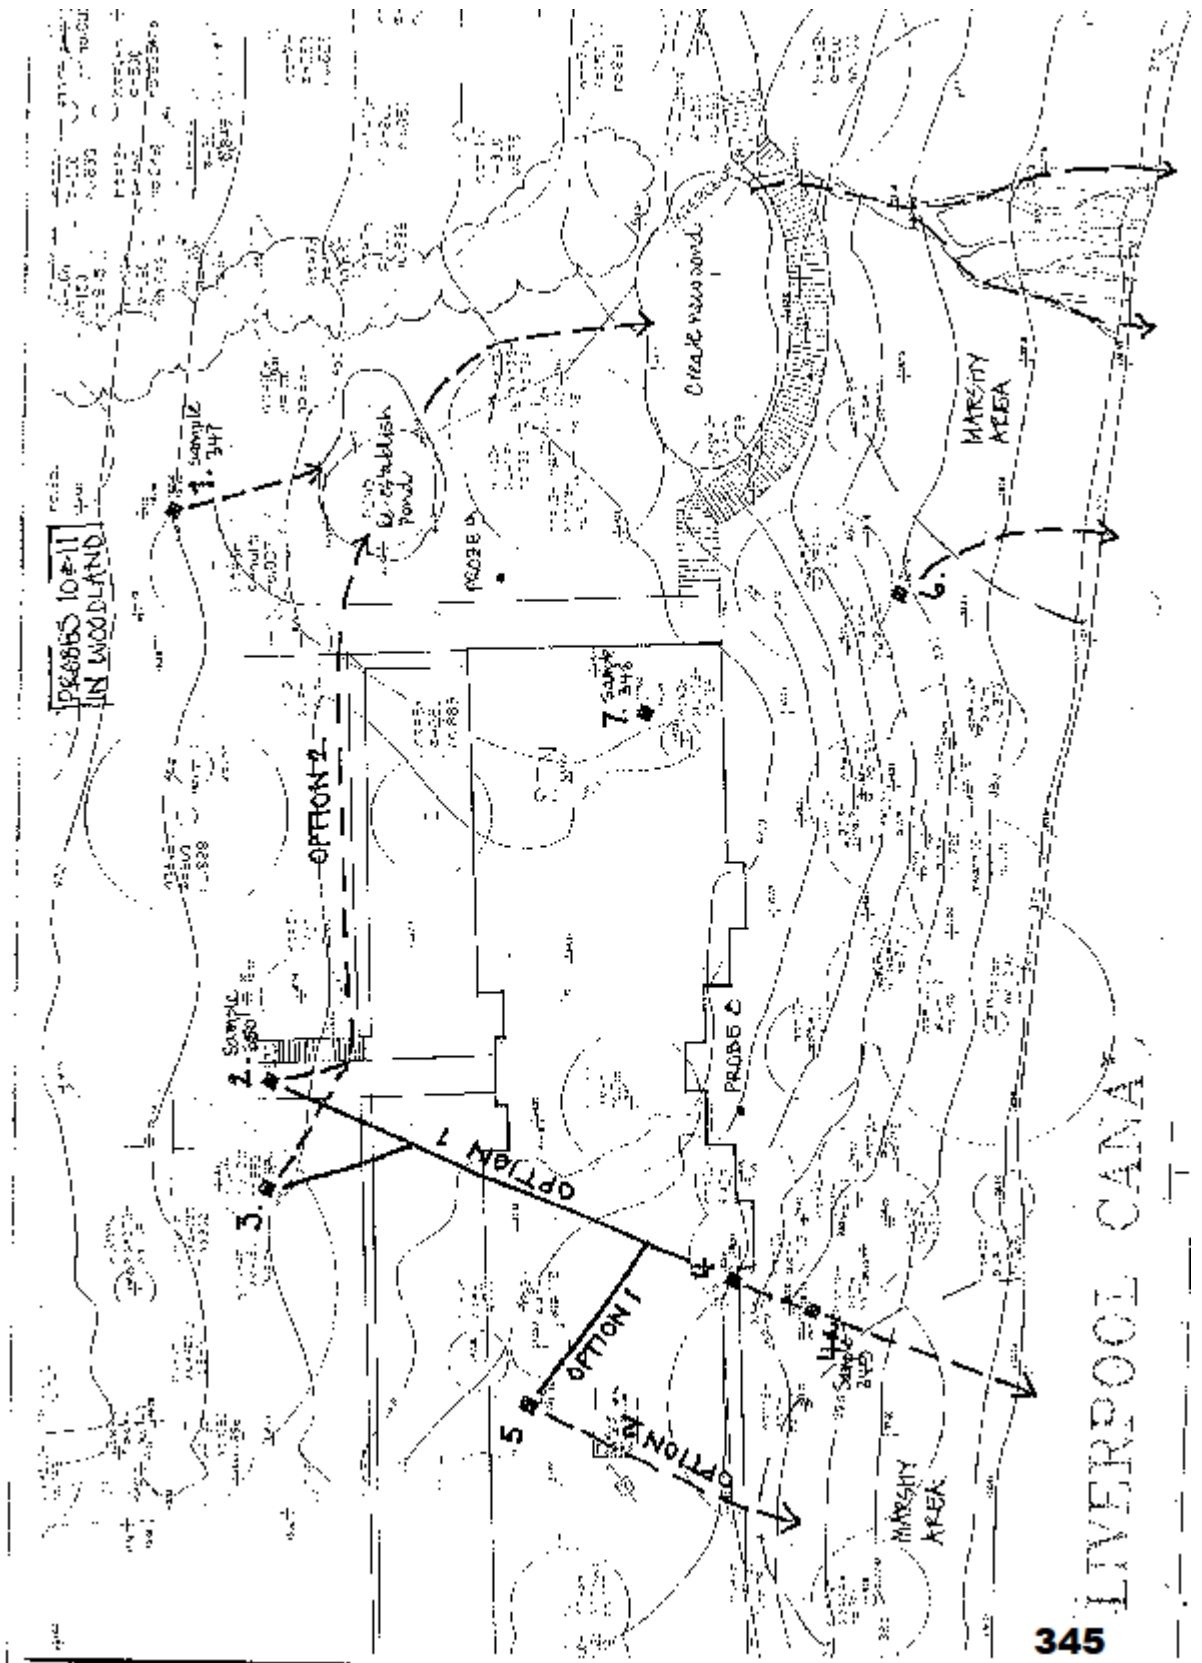
47. It will be seen from *Figure 3* that issues/springs 2 and 3 arise immediately to the west of the proposed F1/F2 Building, whilst issues/springs 4 and 5 arise underneath the footprint of the F1/F2 Building itself. Moreover, for issue/spring 5, both of the recommended options required culverting.
