In the Privy Council

OIVIND LORENTZEN, as Director of Shipping
and Curator of The Royal Norwegian Govern-
ment,
(Plaintiff) *Appellant.*

THE SHIP "ALCOA RAMBLER" (Alcoa Steam-
ship Company Inc. Owners),
(Defendant) *Respondent.*

Record of Proceedings

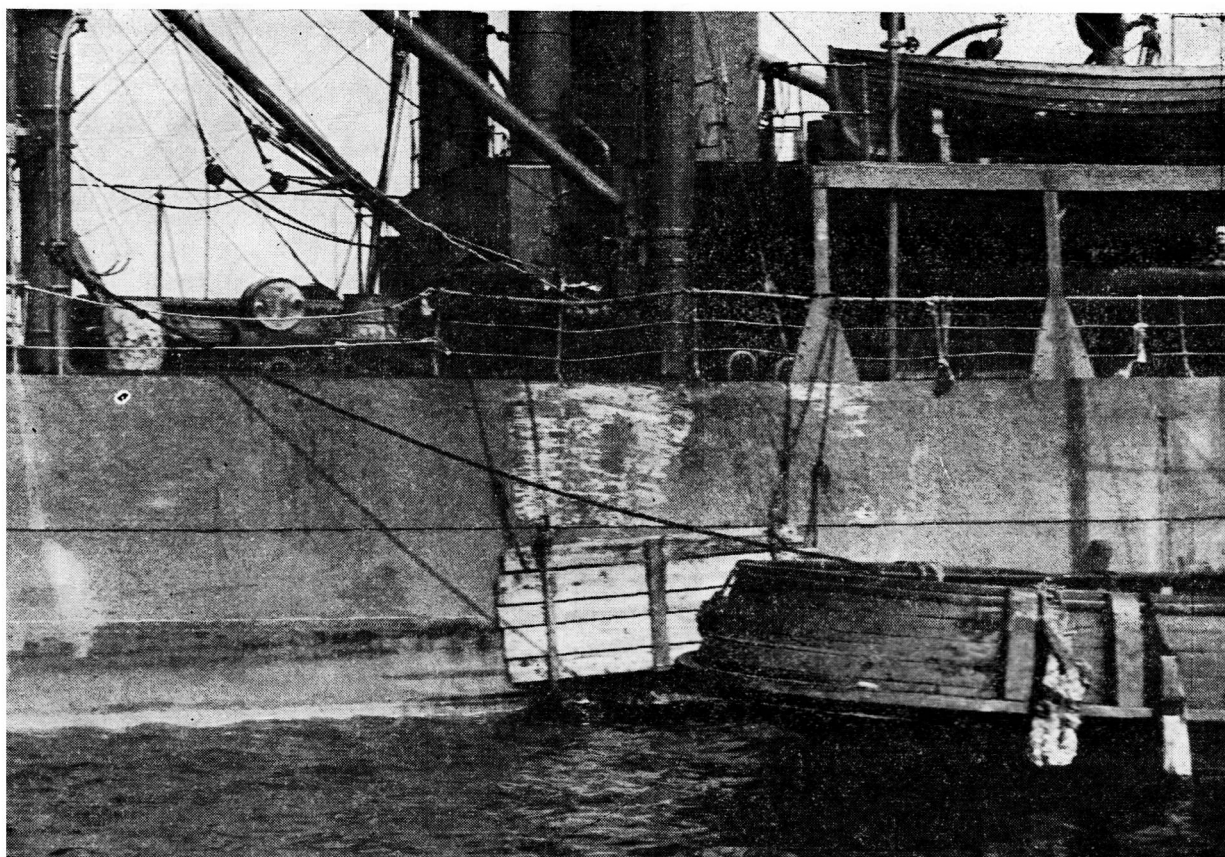
Exhibit No. 2
Alcoa Rambler (Defendants)
Photograph of S. S. Norefjord

At 9. 18 A.M. our vessel collided with the S.S. Norwegian Norefjord.
As a result of this collision our vessel sustained damage to her bows. The
NOREFJORD seriously damaged on port side amidships.

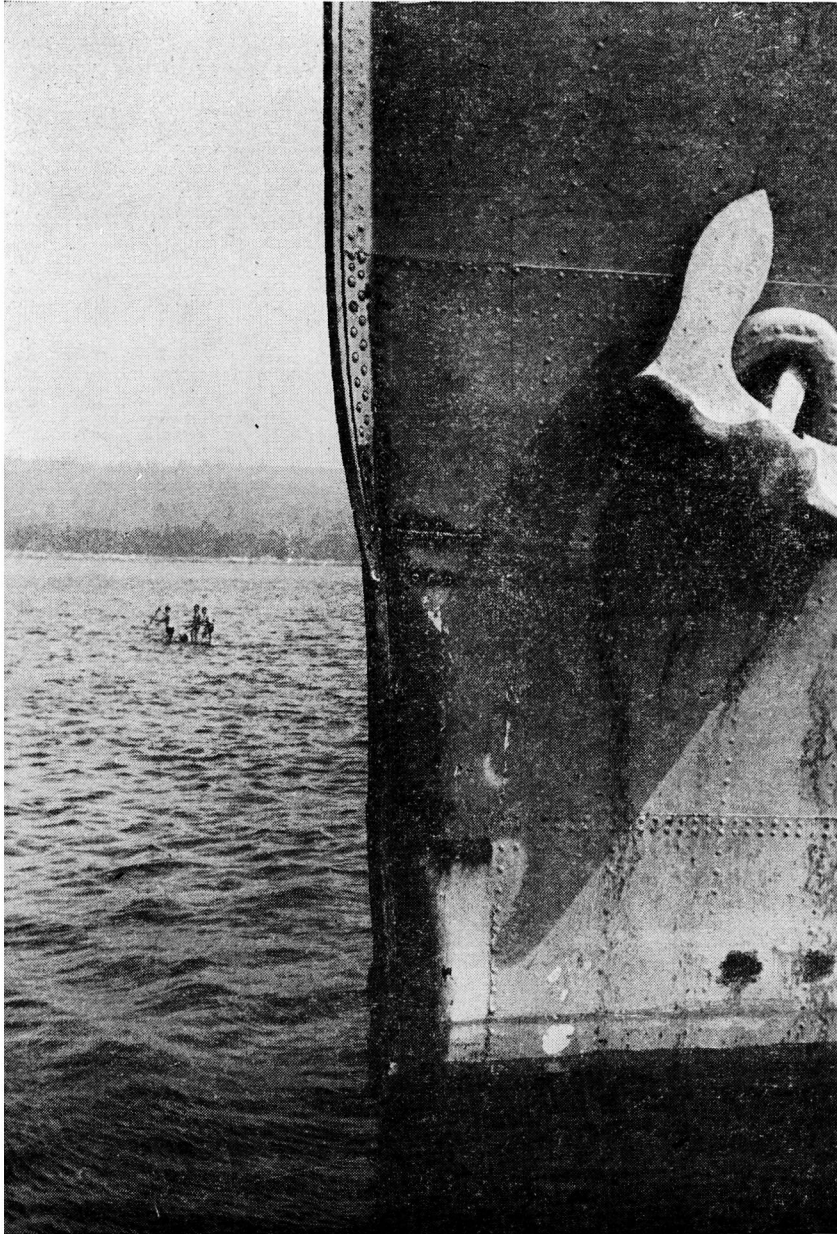
**Norefjord's (Plaintiff's)
Exhibit No. 11
Photograph of Alcoa Rambler**

AT 9.18 A.M. our vessel collided with the S/S Norwegian Norefjord. As a result of this collision our vessel sustained damage to her bow. The Norefjord seriously damaged on port side amidship.

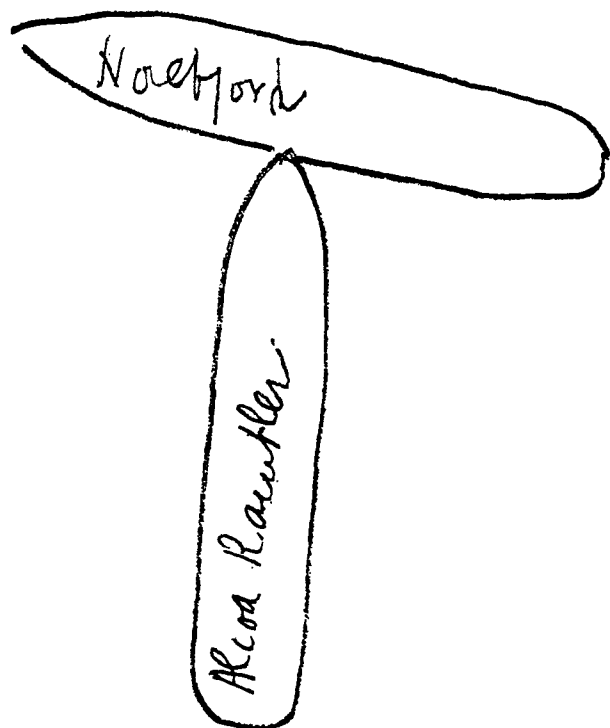
**Norefjord's (Plaintiff's)
Exhibit No. 3**

Position of ships by Master of "Norefjord."

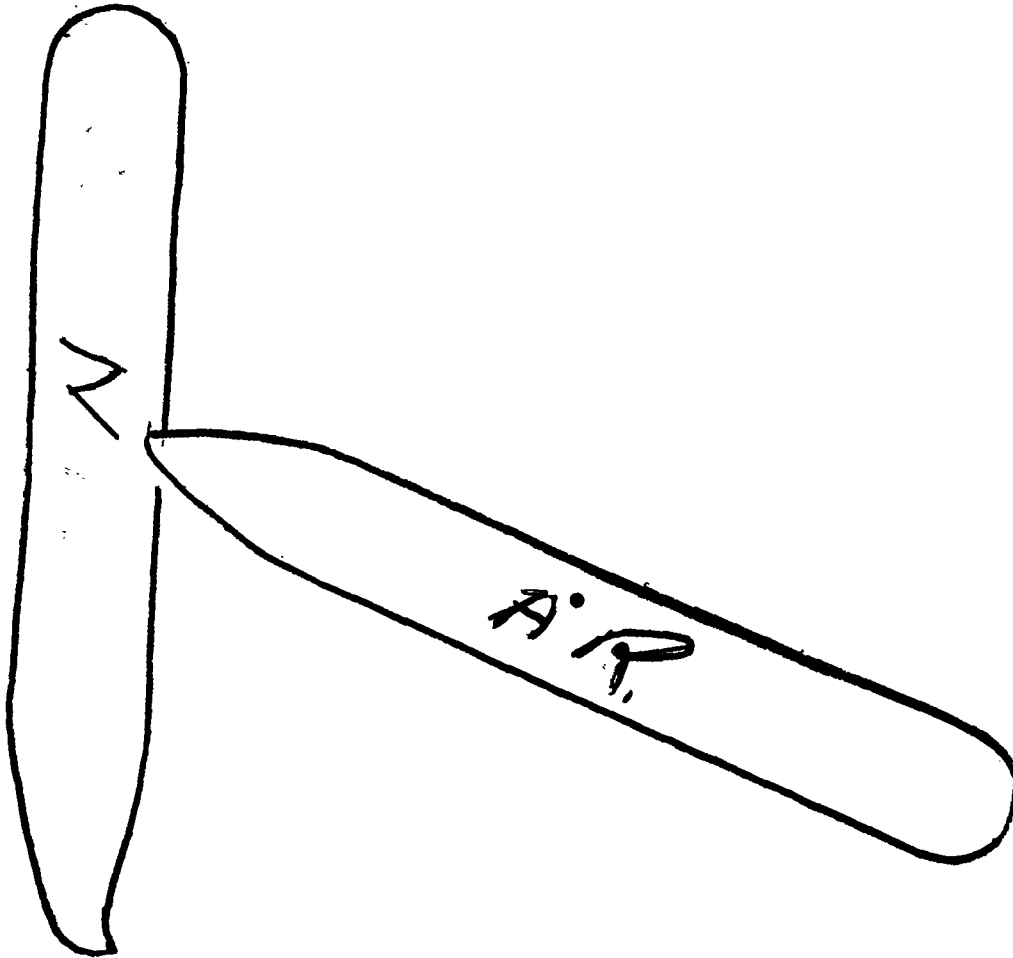
Alcoa Rambler's (Defendant)
Exhibit No. 16

Diagram of collision
by C. Tupper Hayes
